# AHERA Triennial Reinspection Report

## **Dixon Montessori Charter School**

**December 20, 2020**

**Project No. A2886**

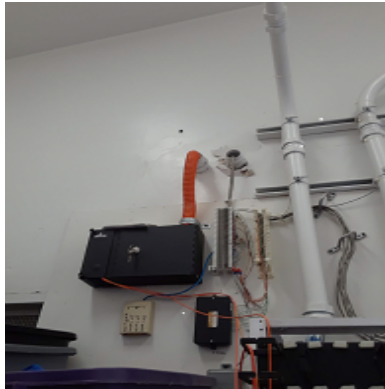
Wing 15-20: Elec./Storage (HM#47)

- **Drywall & Joint Compound** – MPR Bldg: MPR & Speech Room Restroom (HM#13)
- **Drywall & Skim Coat** - Wing 15-20: Elec/Storage (HM#47)
- **Smooth Plaster** – Wing 15-20: Boys Restroom next to P.E Storage (HM#48)
- **Plaster Wall** – Office (HM#10)

Damaged, friable surfacing and miscellaneous ACBMs, all of which were assumed to contain asbestos, were identified during the Triennial Reinspection of Dixon Montessori Charter School. These materials have been assessed as *damaged friable surfacing ACBMs* (i.e., Risk Assessment Category 2) and *damaged or significantly damaged friable miscellaneous ACBMs* (i.e., Risk Assessment Category 4). The response action options available are encapsulation, enclosure, removal, or repair. Based on the damage identified, Aurora ESI recommends that the materials be repaired. See the **AHERA: Triennial Reinspection Report** inspection table for specific locations and descriptions of damaged ACBMs. Photos are included for materials with significant damage.

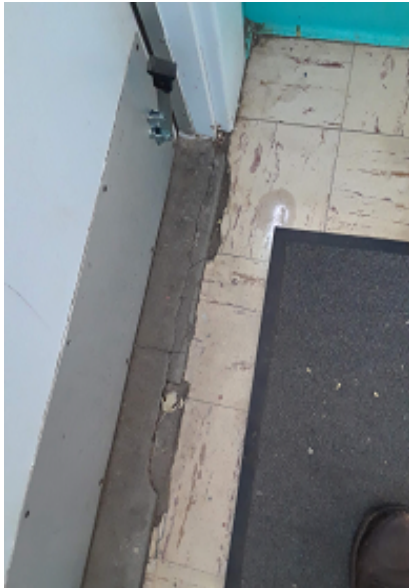
**Wing 5-9: Rm. 7 (HM#25)**

- 12" VFT (Mottled) & Adhesive - Portable 24 (HM#52)
- 9" VFT (Beige w/ Red) & Adhesive - Wing 5-9: Rooms 6 & 9 (HM#25)
- 9" VFT (Beige w/ Black) & Adhesive - Wing 5-9: Rooms 5, 7, & 8 (HM#26)
- 9" VFT (Red) & Adhesive - MPR Bldg: MPR & Stage (HM#8), Wing 10-14: Rooms 12 & 13 (HM#8)
- 9" VFT (Tan w/ Red) & Adhesive - Wing 1-4: Room 2 (HM#19)
- Sheet Vinyl Flooring (Tile Pattern) & Adhesive - Wing 1-4 and Restrooms (HM#21)
- 9" VFT (Red w/ White Stripe) & Adhesive - Wing 10-14: Rooms 11 & 14 (HM#33)
- 9" VFT (Maroon) & Adhesive - Wing 10-14: Room 13 (HM#36)
- 12" VFT (White w/ Dots) - Classroom 21 (HM#38)

Damaged nonfriable miscellaneous ACBMs were identified during the Triennial Reinspection. These ACBMs do not require an AHERA assessment or associated response action. However, Aurora ESI recommends that DUSD repair these damaged ACBMs in accordance with their O&M Plan to reduce the possibility of the ACBM becoming friable as a result of continued damage or degradation. Following is a list of the damaged nonfriable ACBMs identified along with the location where damage was observed:
